INFORMATION REPORT

COUNTRY	USSR (Murmansk Oblast)	REPORT	
SUBJECT	Observation Towers, Military Barracks, and Road Conditions in the Petsamo Area	DATE DISTR.	29 April 1953
		NO. OF PAGES	3
DATE OF INFO.		REFERENCE NO.	RD 50X1-HUM
PLACE ACQUIRED		REFERENCES

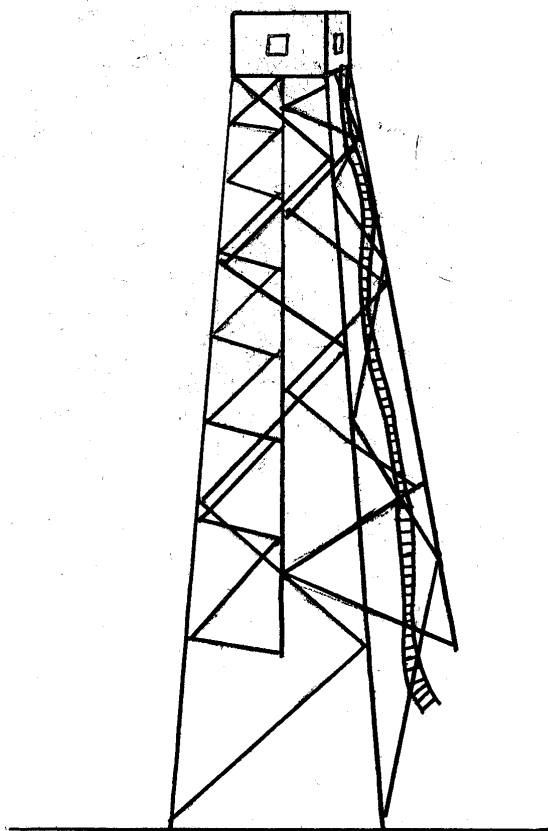
Sketch of Observation Tower

1. Eight watchtowers were observed in the area south of Pechenga (N69-33, E31-12) located on natural hills and command a wide view of the area. They are of wooden construction and consist of four main poles and several cross pieces. The four main support poles slant inward toward the top of the tower, which consists of a square, box-like, enclosed observation platform with a window in each direction. A crude wooden ladder, which is attached to the cross pieces, leads to the top of the tower. Most of the towers observed were of a whitish color and appeared to be newly constructed. (See sketch on page 3.)
